WIREBONDS STATUS

HIRA BB7-1500

Si-detector Inspection Record

Inspected detector(s): dE, E (p+b)

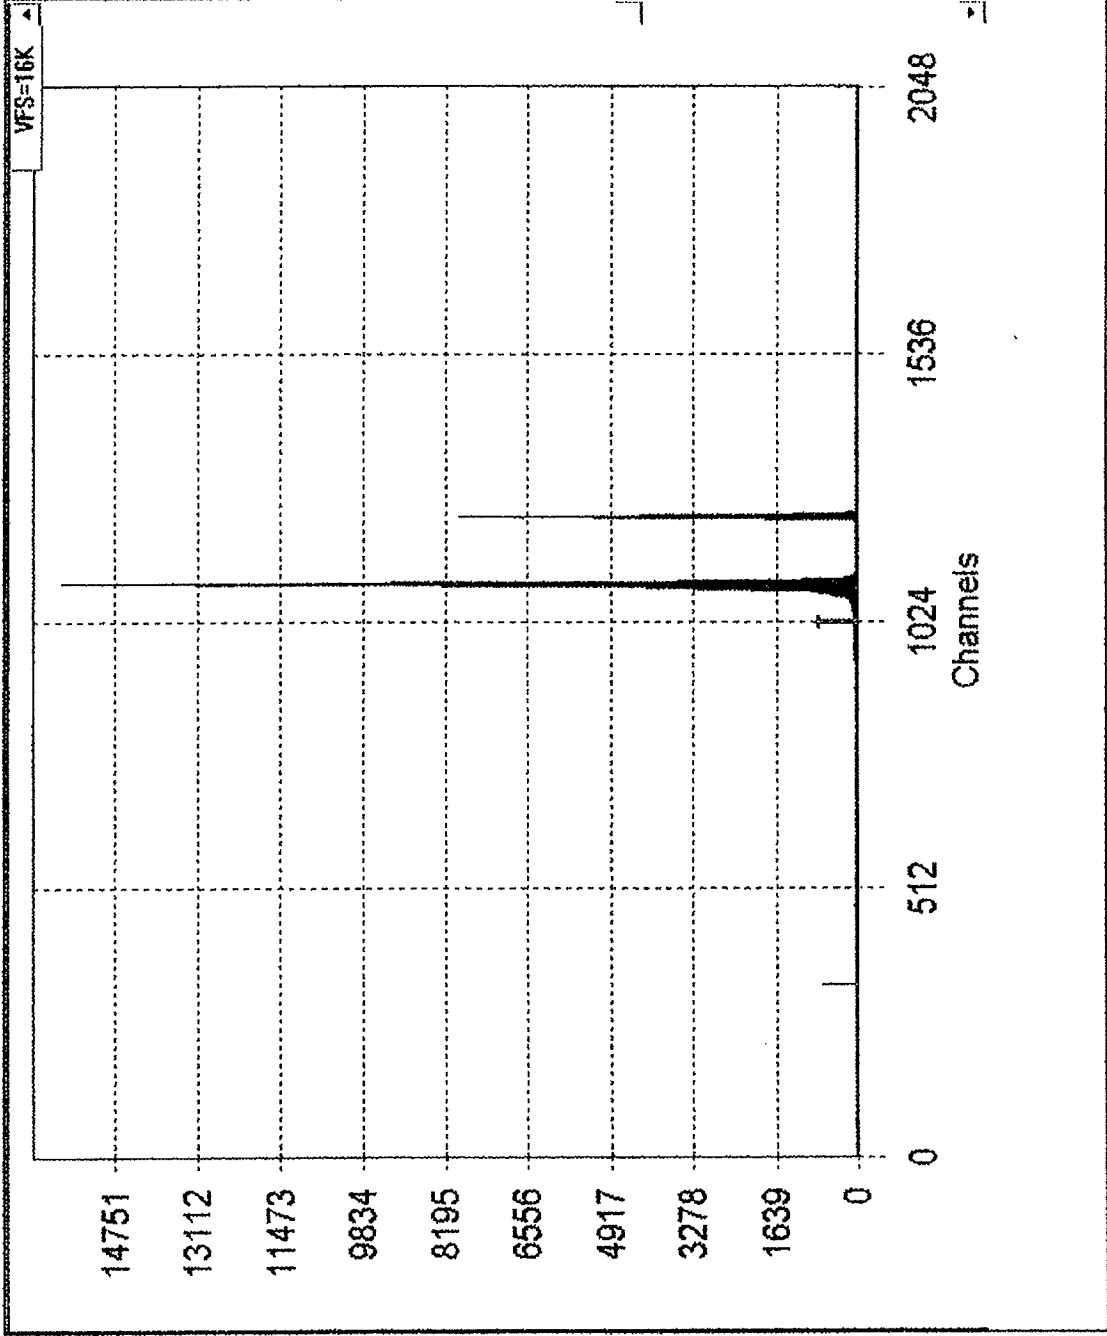
DET LINE: **34.3** KeV
SYSTEM: **22.6** KeV
CAL: **25.8** KeV

DET LINE: **35** KeV
SYSTEM: **22.4** KeV
CALC: **26.8** KeV
