# Si-detector Inspection Record

Inspected detector(s): dE(2297-10) + E(2344-3)  
*dE removed*

**Noise tests of detector n.: 2344-03 in telescope n.: 11**

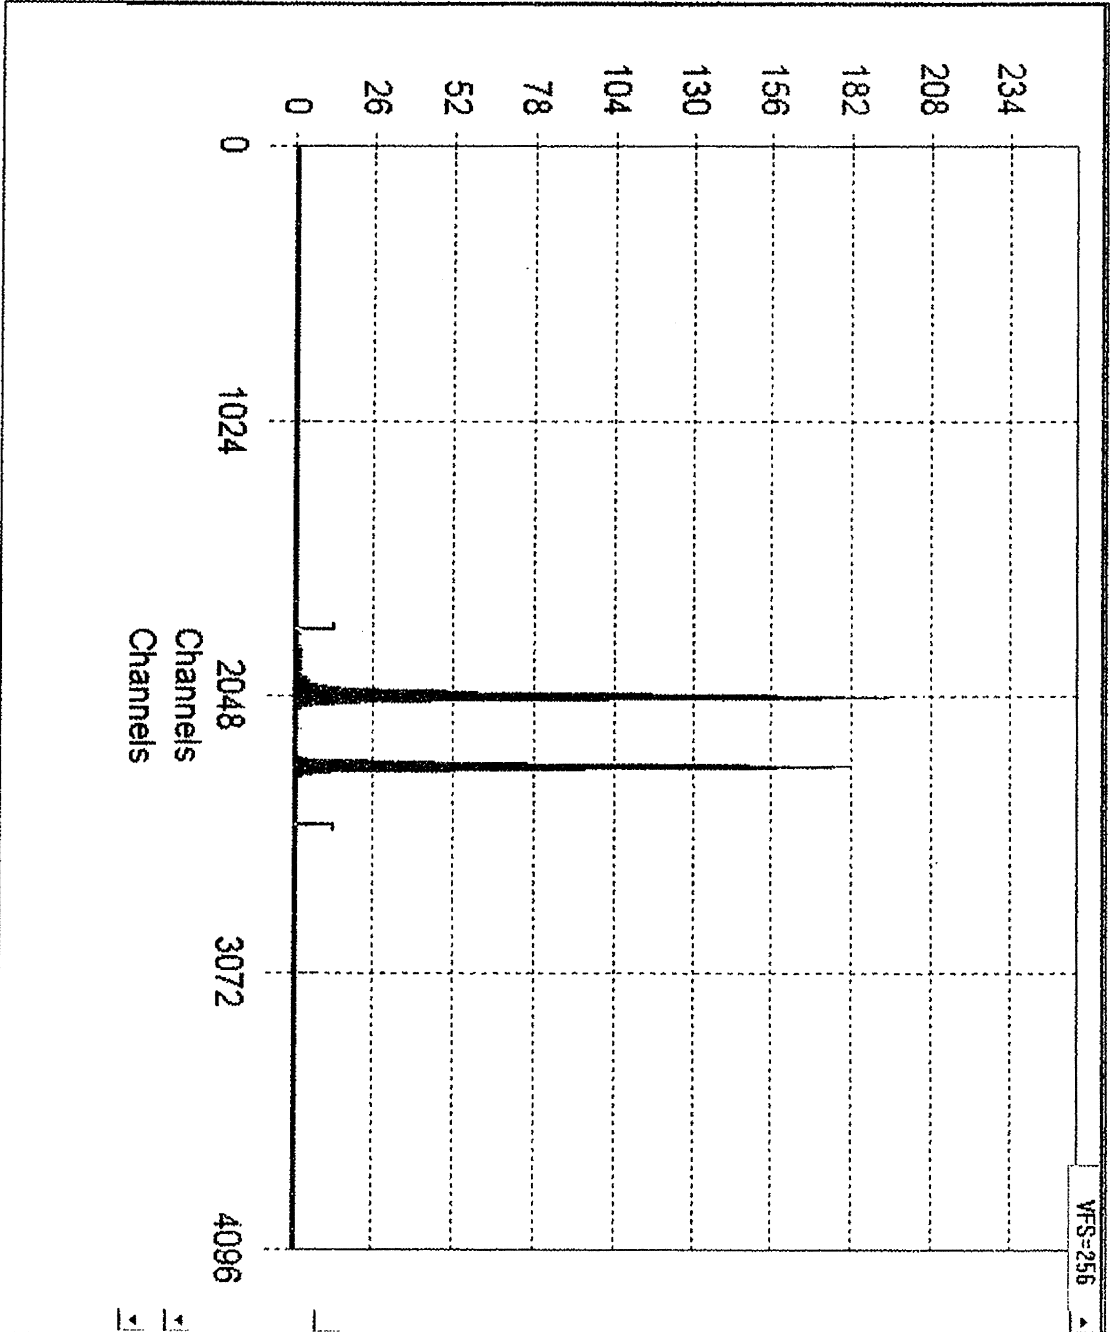
# Resolution Test

DET LINE: **59.1** KeV  
SYSTEM: **50** KeV  
CAL: **31.5** KeV

DET LINE: **61.5** KeV  
SYSTEM: **49.9** KeV  
CALC: **36** KeV

BIAS VOLTS= **350** V Leakage **1400** nA
