TJ 12

Wafer No. 2113-7

INDIANA UNIVERSITY

Si-detector Inspection Record

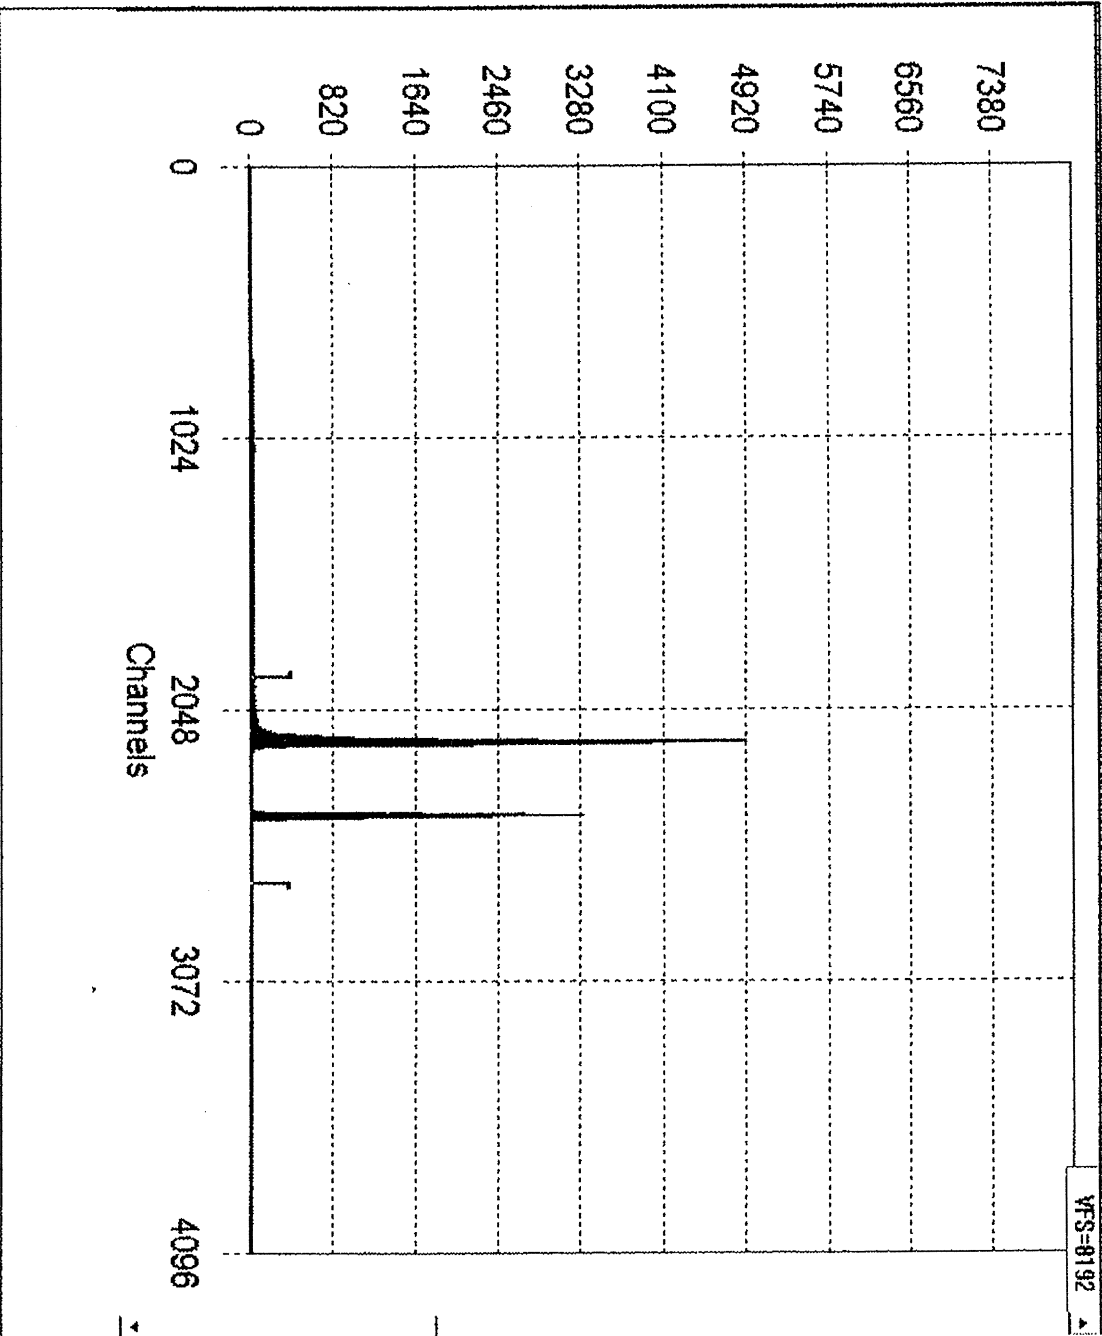
Resolution Plot

DET LINE: **52.1** KeV
SYSTEM: **39** KeV
CAL: **34.5** KeV

DET LINE: **53** KeV
SYSTEM: **38.1** KeV
CALC: **36.8** KeV

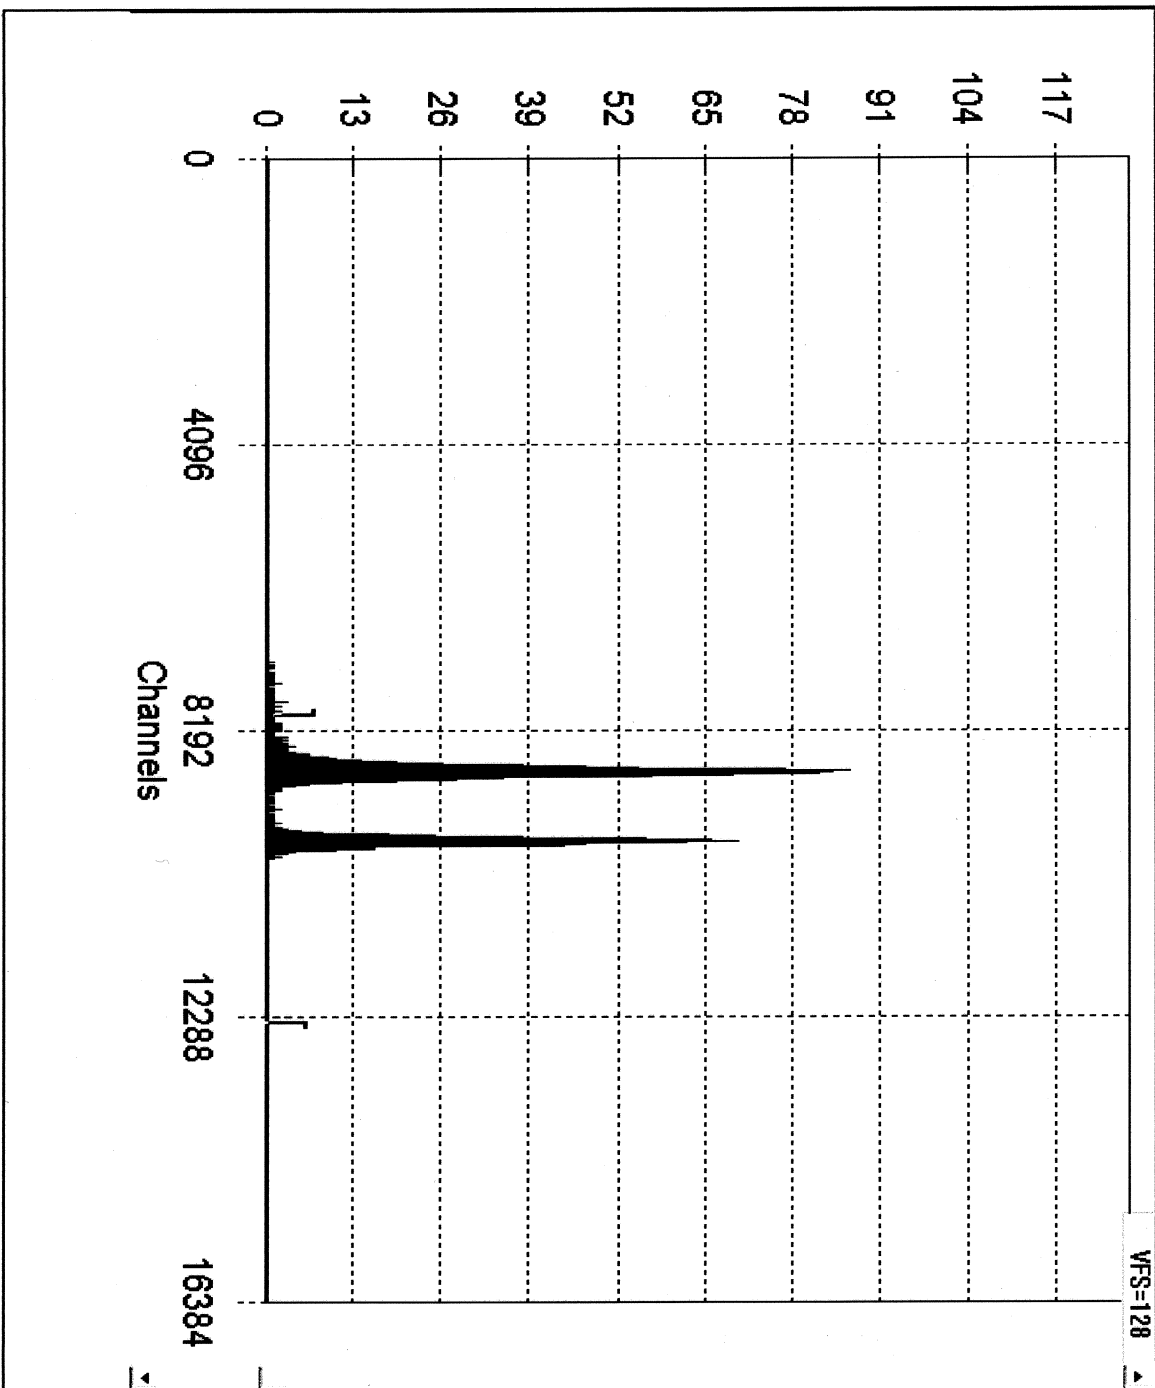
Resolution Plot

T LINE: 83 KeV

STEM: 62.1 KeV

LC: 55 KeV
