**WIREBONDS STATUS**

DEVICE NUMBER: 2113-6  
 THICKNESS: 1473uM

# Si-detector Inspection Record

Date: 16/02/2007  
 Time: 10:00pm  
 Inspected detector(s): 01E(2266-8)+E(2113-6)

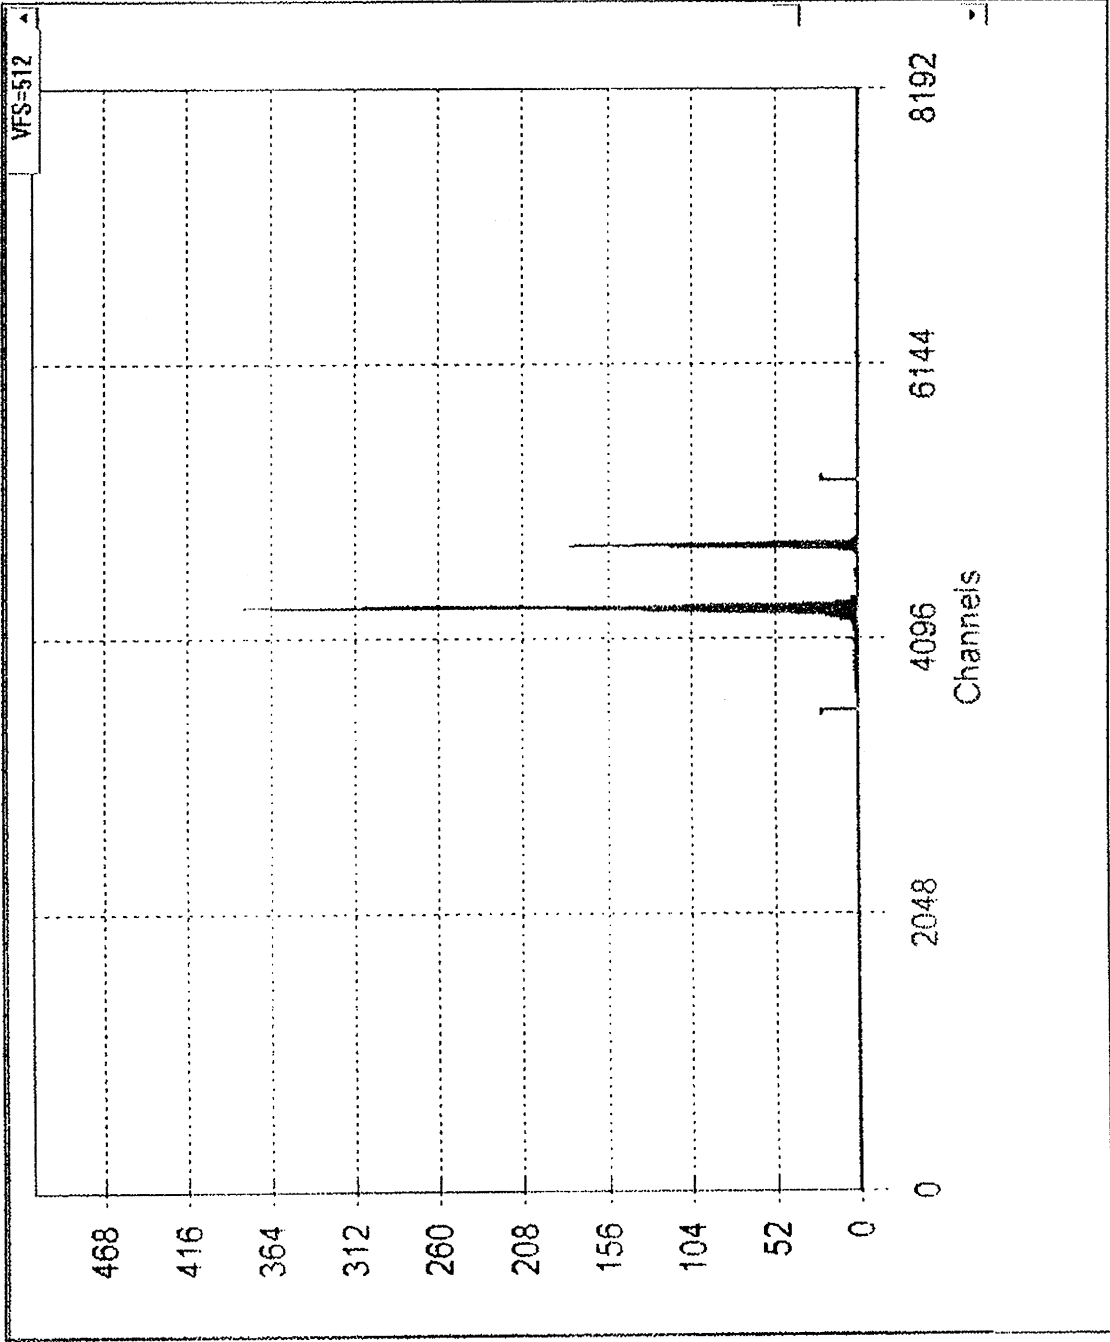
# Resolution Plot

48.1 KeV  
37.7 KeV  
29.9 KeV

52.1 KeV  
37.8 KeV  
35.8 KeV
