## BB7-1500

Water No: **2403-2** Thickness: **1533**  $\mu\text{m}$  Depletion: **280** Volts

# Si-detector Inspection Record

**Date:** 9/23/07      **Time:** ~21:00  
**Tel n.:** 14      **Inspected detector(s):** dE+E  
**1st inspector:** Vlad HENZL  
**2nd inspector:** Davidka HENZLOVA

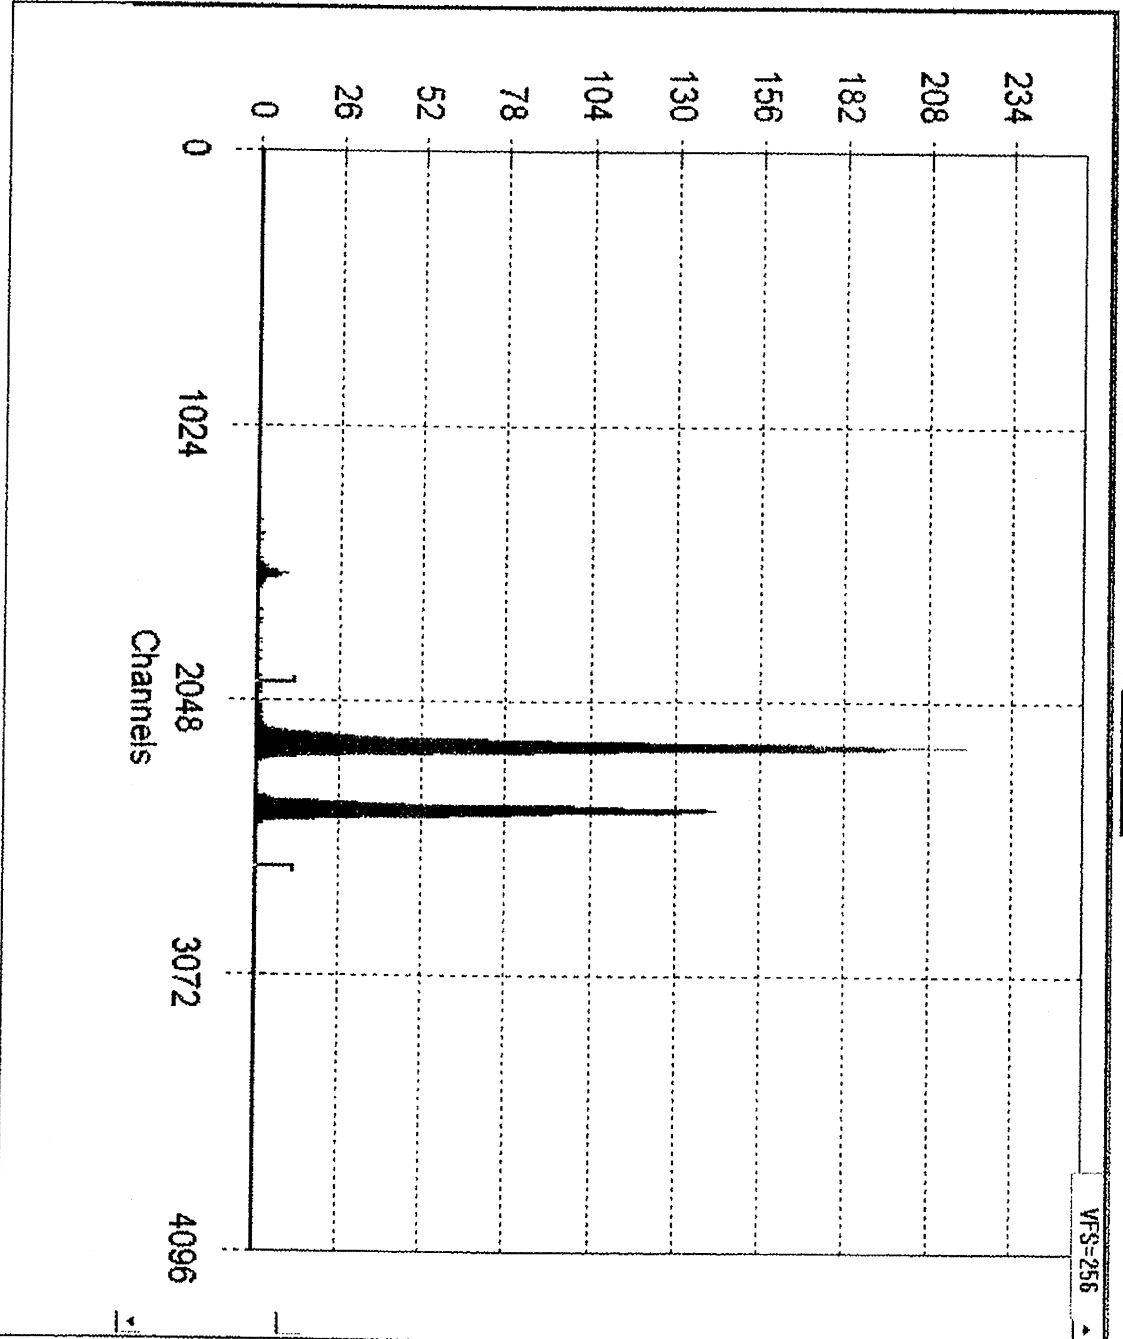
# Resolution Test

DET LINE: **76.1** KeV  
SYSTEM: **63.6** KeV  
CAL: **41.8** KeV

DET LINE: **78** KeV  
SYSTEM: **63.5** KeV  
CALC: **42.3** KeV

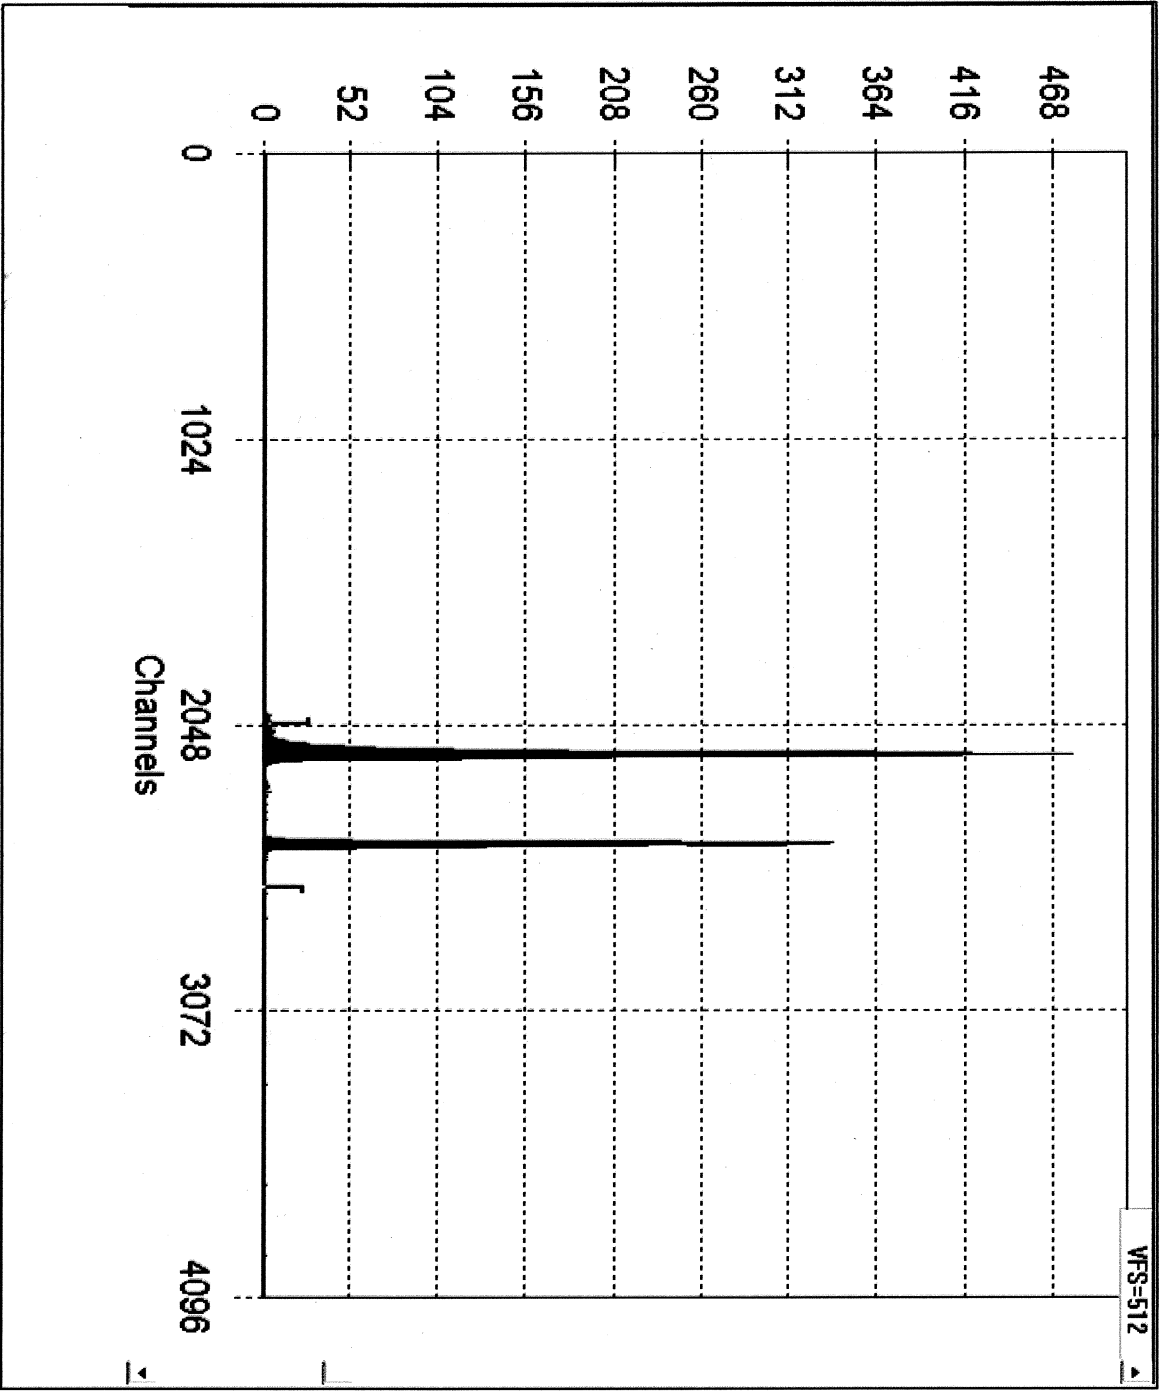
# Resolution Plot

T LINE:  81.9 Kev  
STEM:  61 Kev  
LC:  54.6 Kev

BIAS VOLTS=  400 V Leakage  1100 nA
