## HIRA BB7

# Si-detector Inspection Record

Noise tests of detector n.: 2405-7 in telescope n.: 19

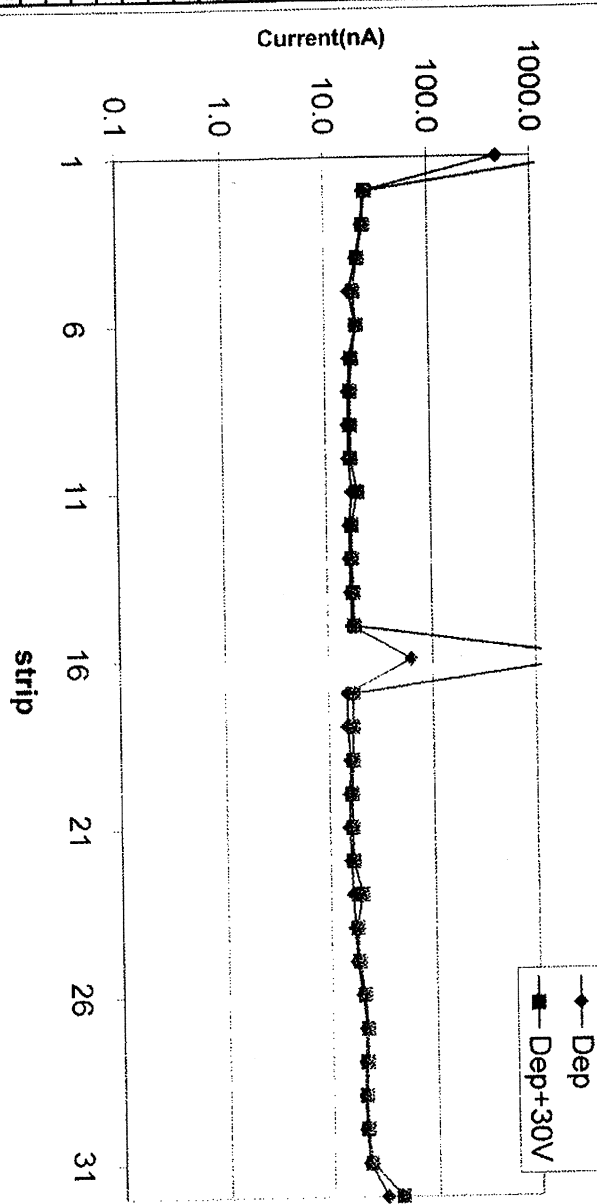
### Front Side Strip Leakage Current

Strip	Current(nA)	Dep+30V
1	470.00	4000.00
2	23.70	24.90
3	22.90	23.50
4	20.20	20.90
5	17.10	18.90
6	19.70	20.00
7	16.90	17.80
8	16.50	17.40
9	16.40	17.30
10	16.40	17.30
11	17.40	19.80
12	16.30	17.30
13	16.30	17.30
14	16.60	17.60
15	16.90	17.90
16	62.20	4000.00
17	15.10	17.10
18	15.00	17.00
19	15.80	16.80
20	15.40	16.40
21	15.30	16.30
22	15.60	16.60
23	16.20	19.90
24	16.70	17.60
25	17.30	18.30
26	19.30	20.30
27	20.80	21.80
28	20.20	21.20
29	19.70	20.70
30	20.10	21.00
31	21.60	22.60
32	31.60	44.40
Total	1081.20	8595.90

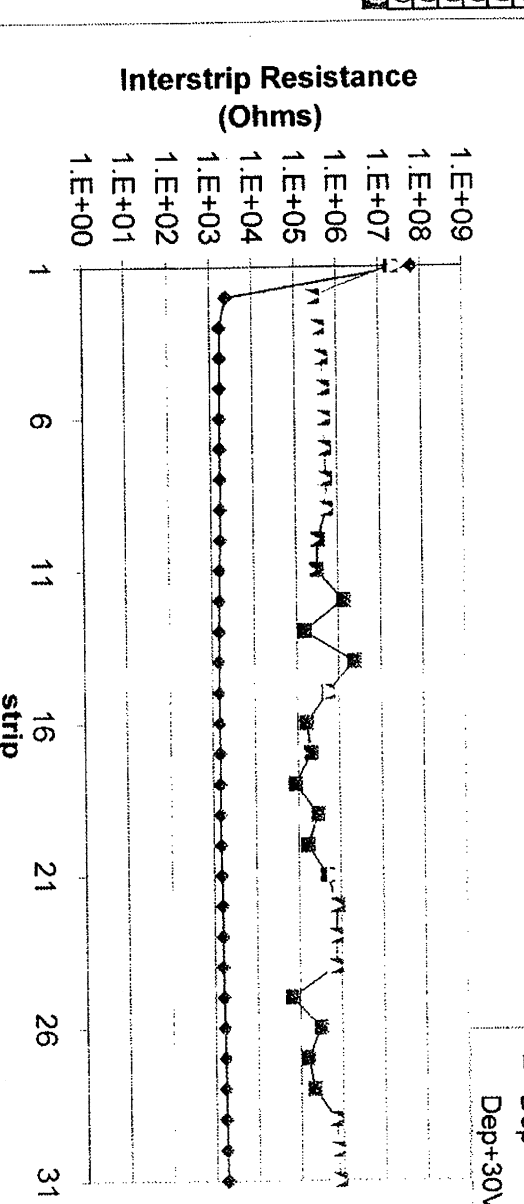
### Back Side Inter-strip Resistance

Strip	0V	Dep	Dep+30V
1	6.2E+07	2.0E+07	2.6E+07
2	2.4E+03	2.8E+05	2.8E+05
3	1.7E+03	3.6E+05	3.6E+05
4	1.7E+03	4.2E+05	4.2E+05
5	1.7E+03	4.6E+05	4.5E+05
6	1.7E+03	4.8E+05	4.7E+05
7	1.7E+03	5.0E+05	4.9E+05
8	1.7E+03	5.2E+05	5.0E+05
9	1.7E+03	5.4E+05	5.2E+05
10	1.6E+03	3.3E+05	2.6E+05
11	1.6E+03	3.1E+05	2.0E+05
12	1.5E+03	1.3E+06	4.9E+05
13	1.5E+03	1.9E+05	5.2E+04
14	1.5E+03	2.3E+06	5.9E+05
15	1.5E+03	5.5E+05	6.2E+05
16	1.5E+03	1.6E+05	6.4E+05
17	1.5E+03	2.0E+05	1.2E+05
18	1.5E+03	8.6E+04	1.8E+04
19	1.5E+03	3.0E+05	1.4E+05
20	1.5E+03	1.7E+05	6.7E+05
21	1.5E+03	4.7E+05	6.9E+05
22	1.5E+03	8.2E+05	6.9E+05
23	1.6E+03	7.3E+05	7.0E+05
24	1.6E+03	7.4E+05	6.8E+05
25	1.6E+03	6.6E+04	2.3E+04
26	1.7E+03	3.1E+05	1.9E+05
27	1.7E+03	1.9E+05	6.1E+04
28	1.7E+03	2.1E+05	9.3E+04
29	1.7E+03	6.7E+05	6.2E+05
30	1.8E+03	7.2E+05	7.2E+05
31	1.8E+03	8.0E+05	7.5E+05

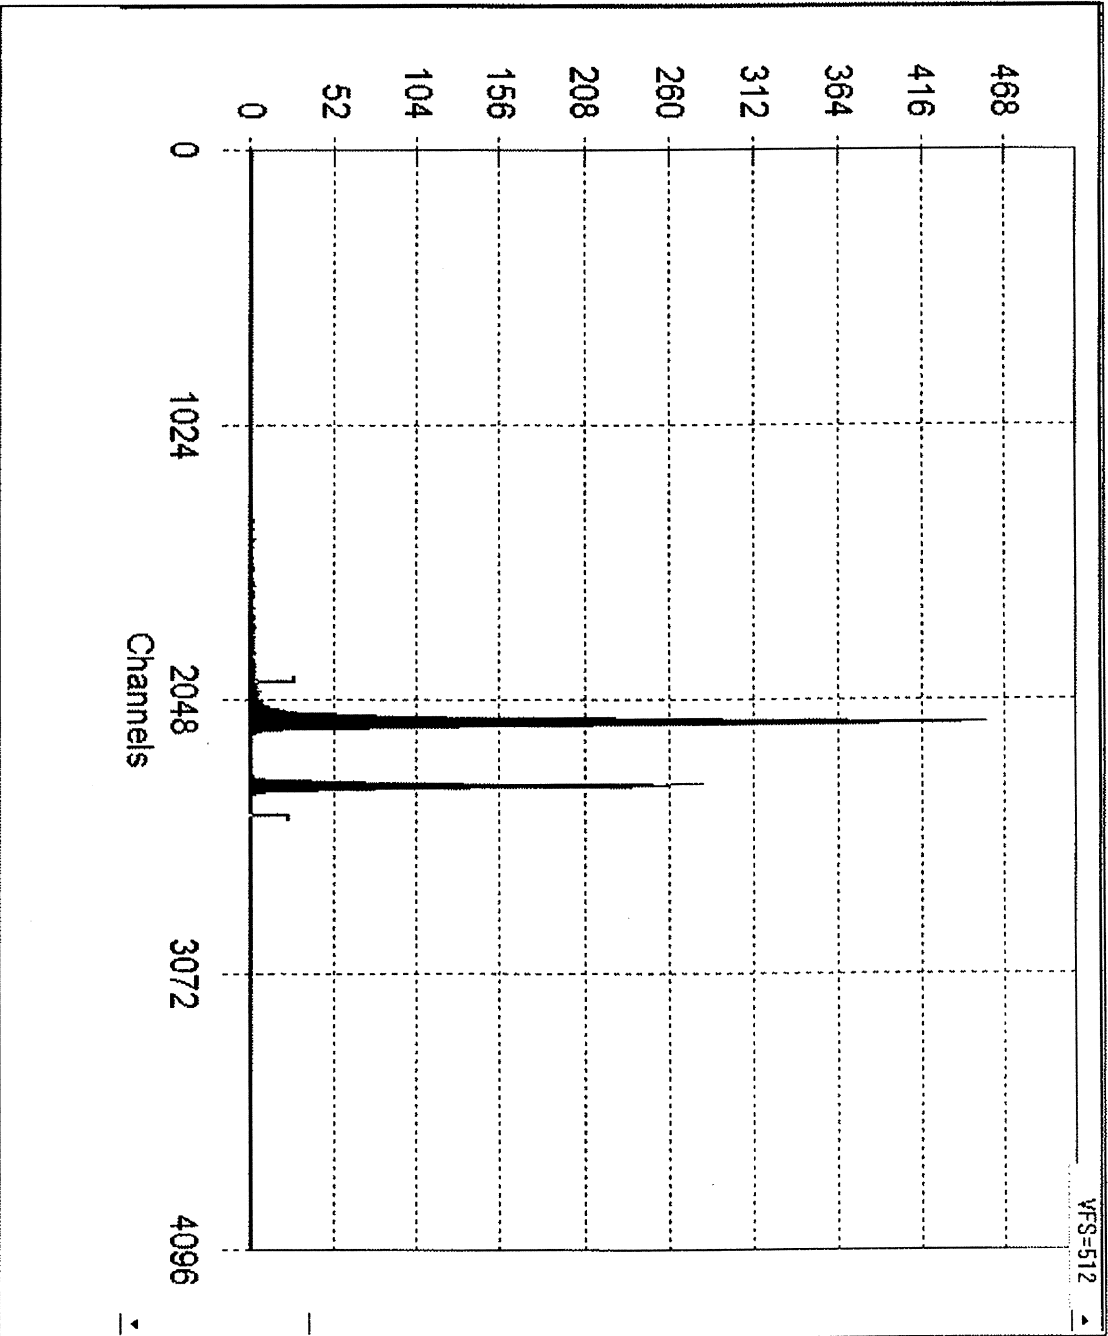
# Resolution Test

DET LINE: **69.5** KeV  
SYSTEM: **48.8** KeV  
CAL: **49.5** KeV

DET LINE: **71.9** KeV  
SYSTEM: **48.6** KeV  
CALC: **52.9** KeV
