BB7-1500

Water No.: 2085-4

Si-detector Inspection Record

Noise tests of detector n.: 2085-4 in telescope n.: 5

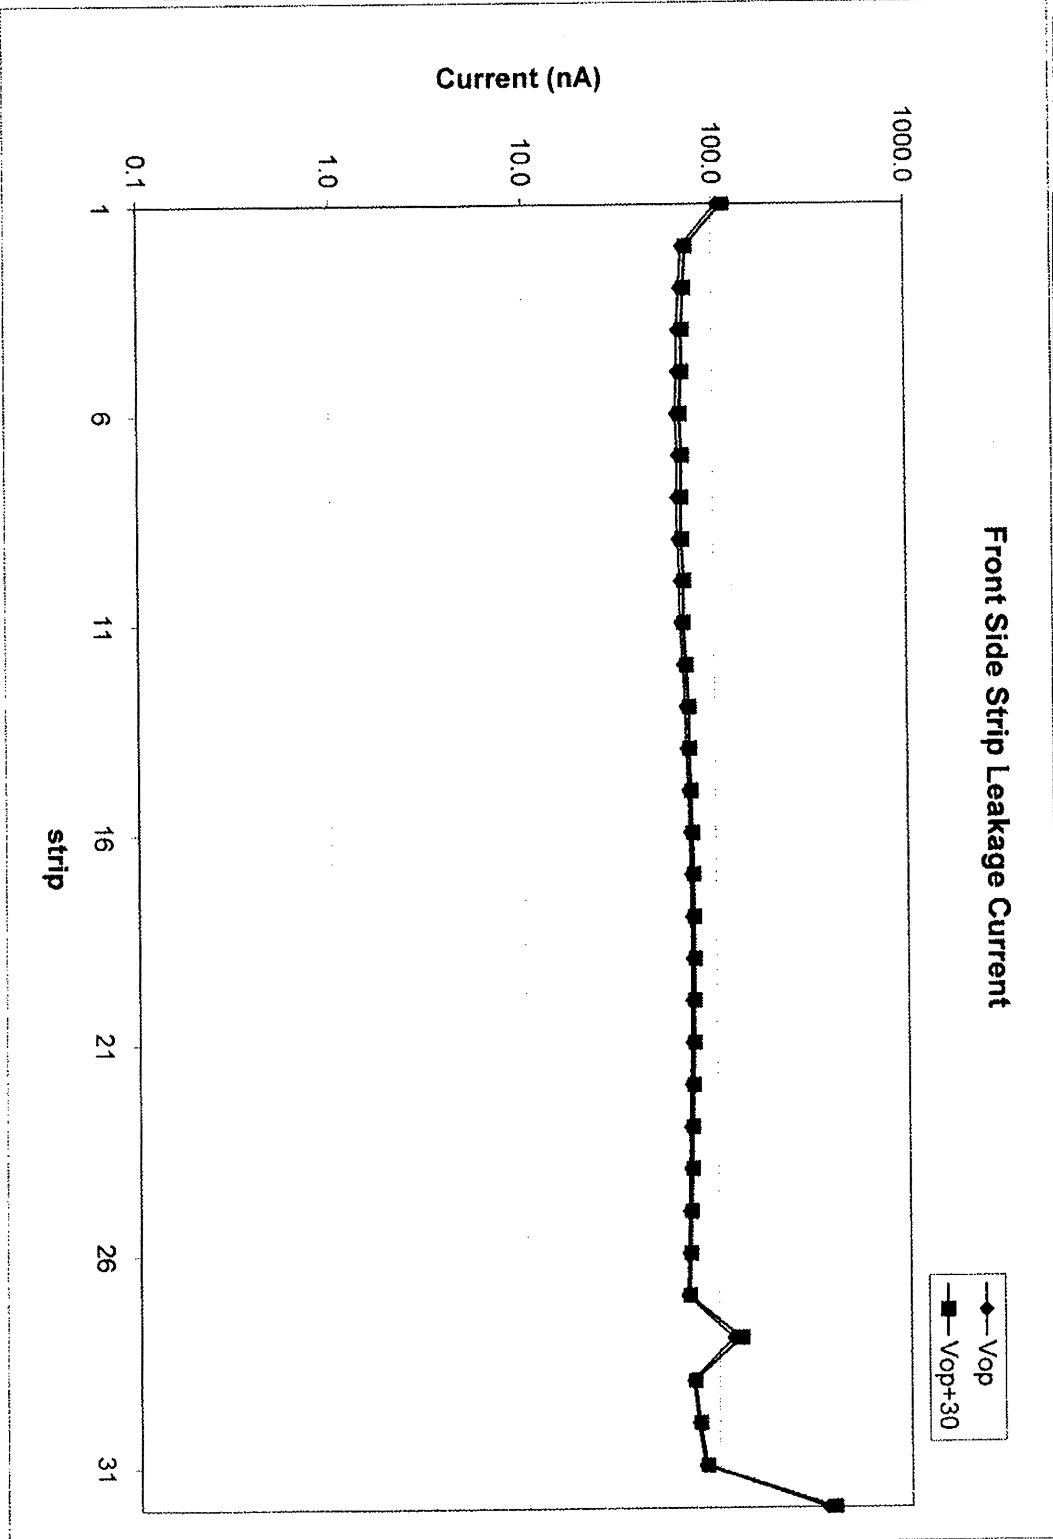
HIGH LEAKAGE CURRENT RESULT DUE TO HIGHER ROOM TEMPERATURE AND HUMIDITY. (See Alpha resolution for current result in vacuum.)

ROOM TEMPERATURE = 25°C

HUMIDITY = 55%

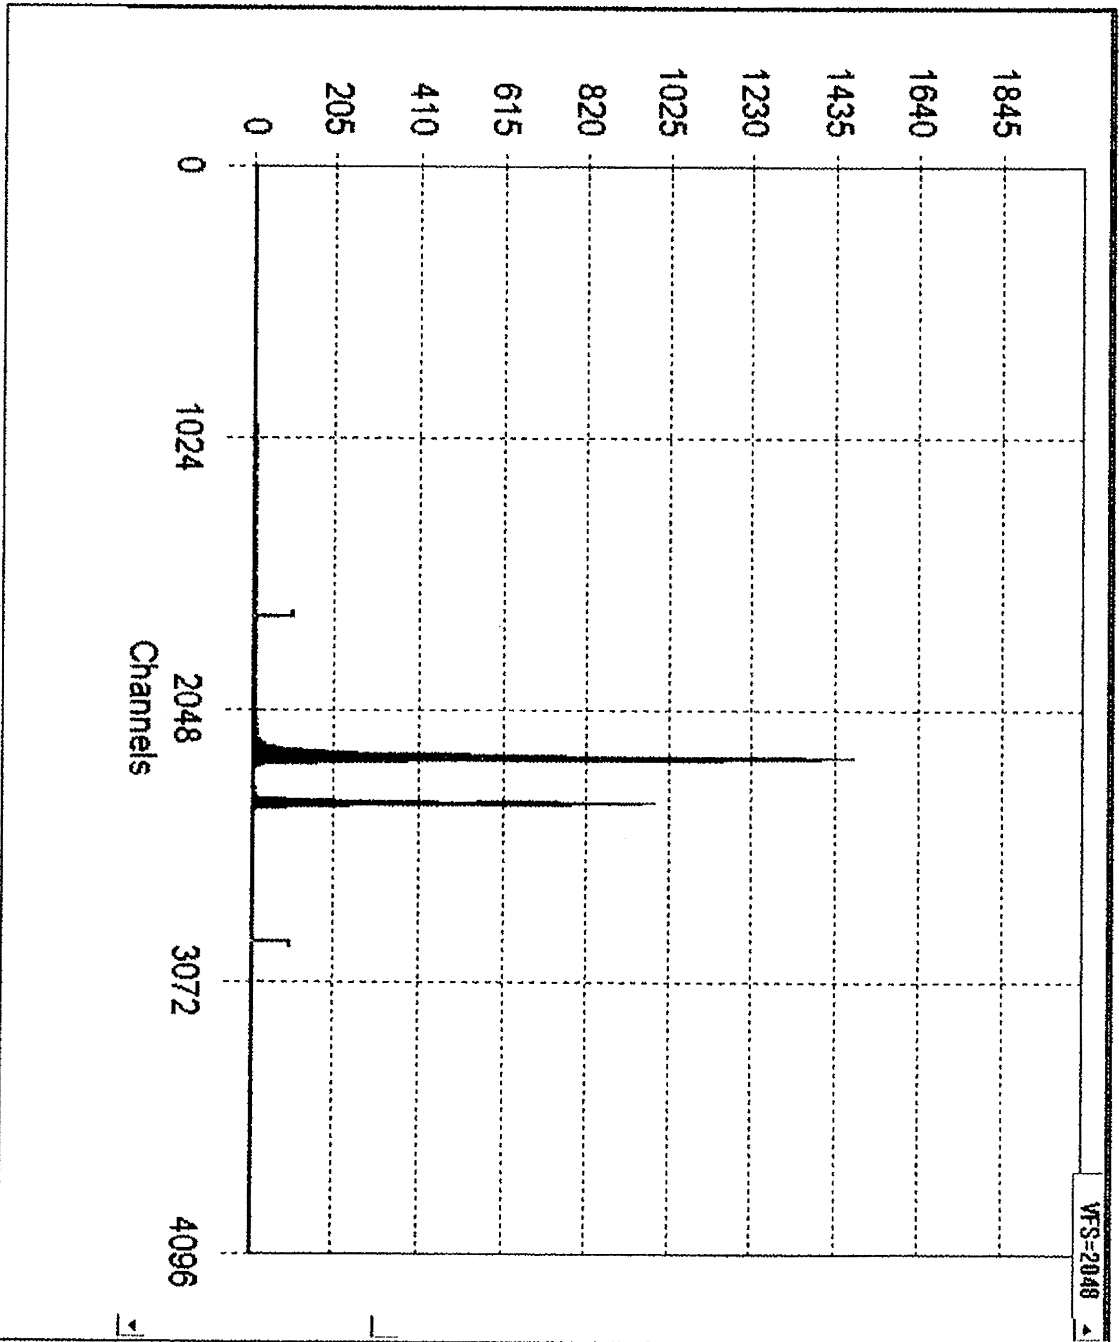
Resolution Plot

DET LINE: 51.1 KeV
SYSTEM: 39 KeV
CAL: 33 KeV

DET LINE: 51.6 KeV
SYSTEM: 38.8 KeV
CALC: 33.9 KeV

Leakage 1950 nA
