Detector Profile

BB7-1500

Wafer No.: **2085-14**

Si-detector Inspection Record

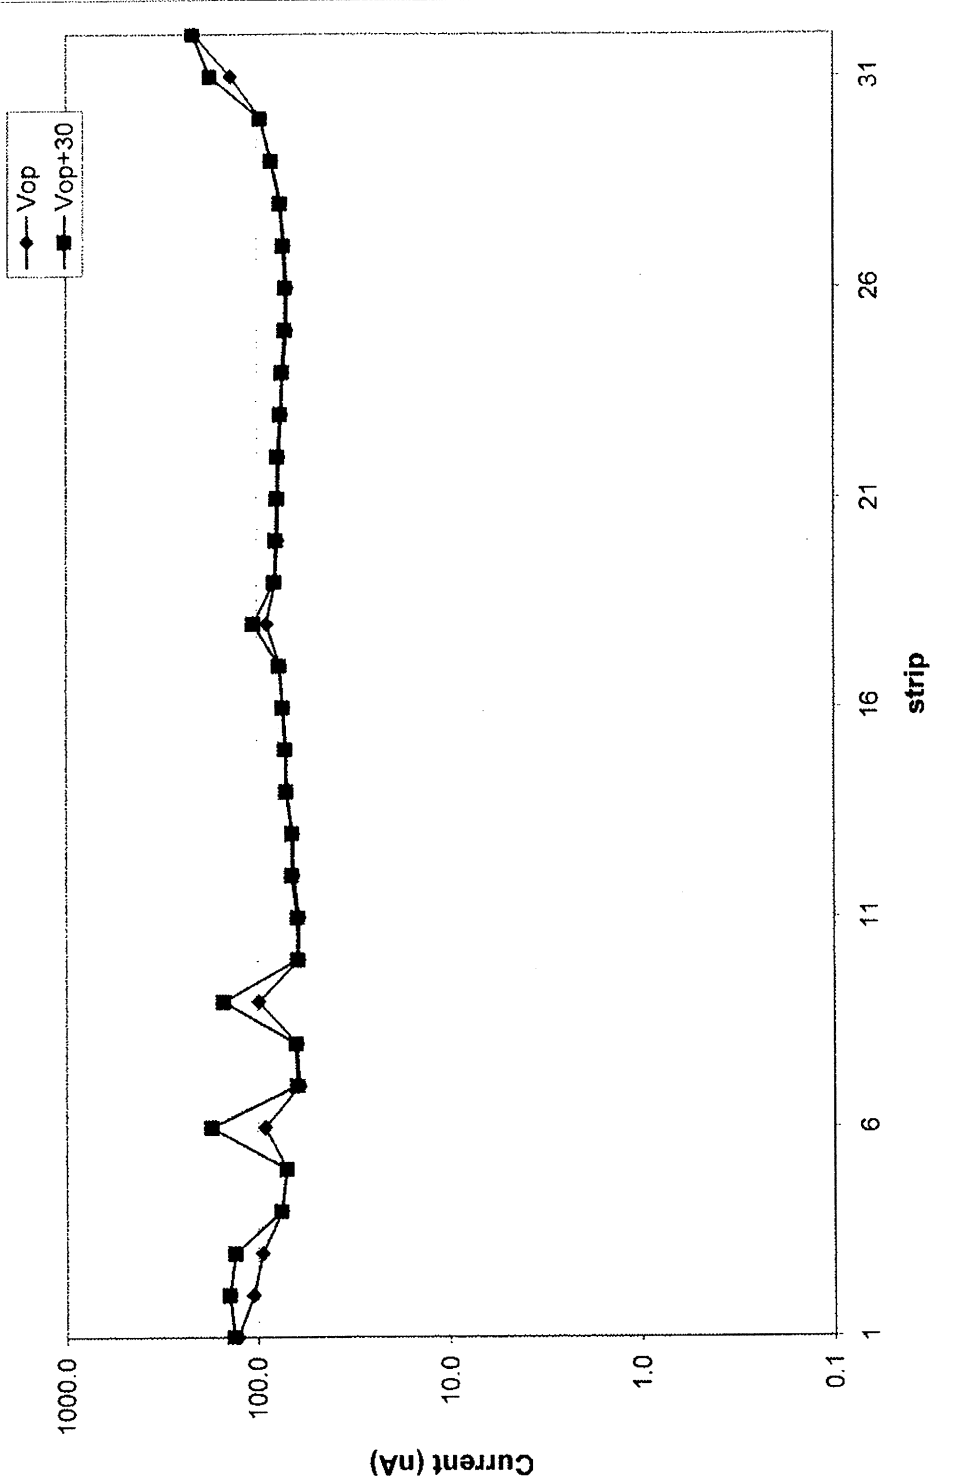
Front Side Strip Leakage Current

HIGH LEAKAGE CURRENT RESULT DUE TO HIGHER ROOM TEMPERATURE AND HUMIDITY. (See Alpha resolution for current result in vacuum.)
 ROOM TEMPERATURE = 25°C
 HUMIDITY = 55%

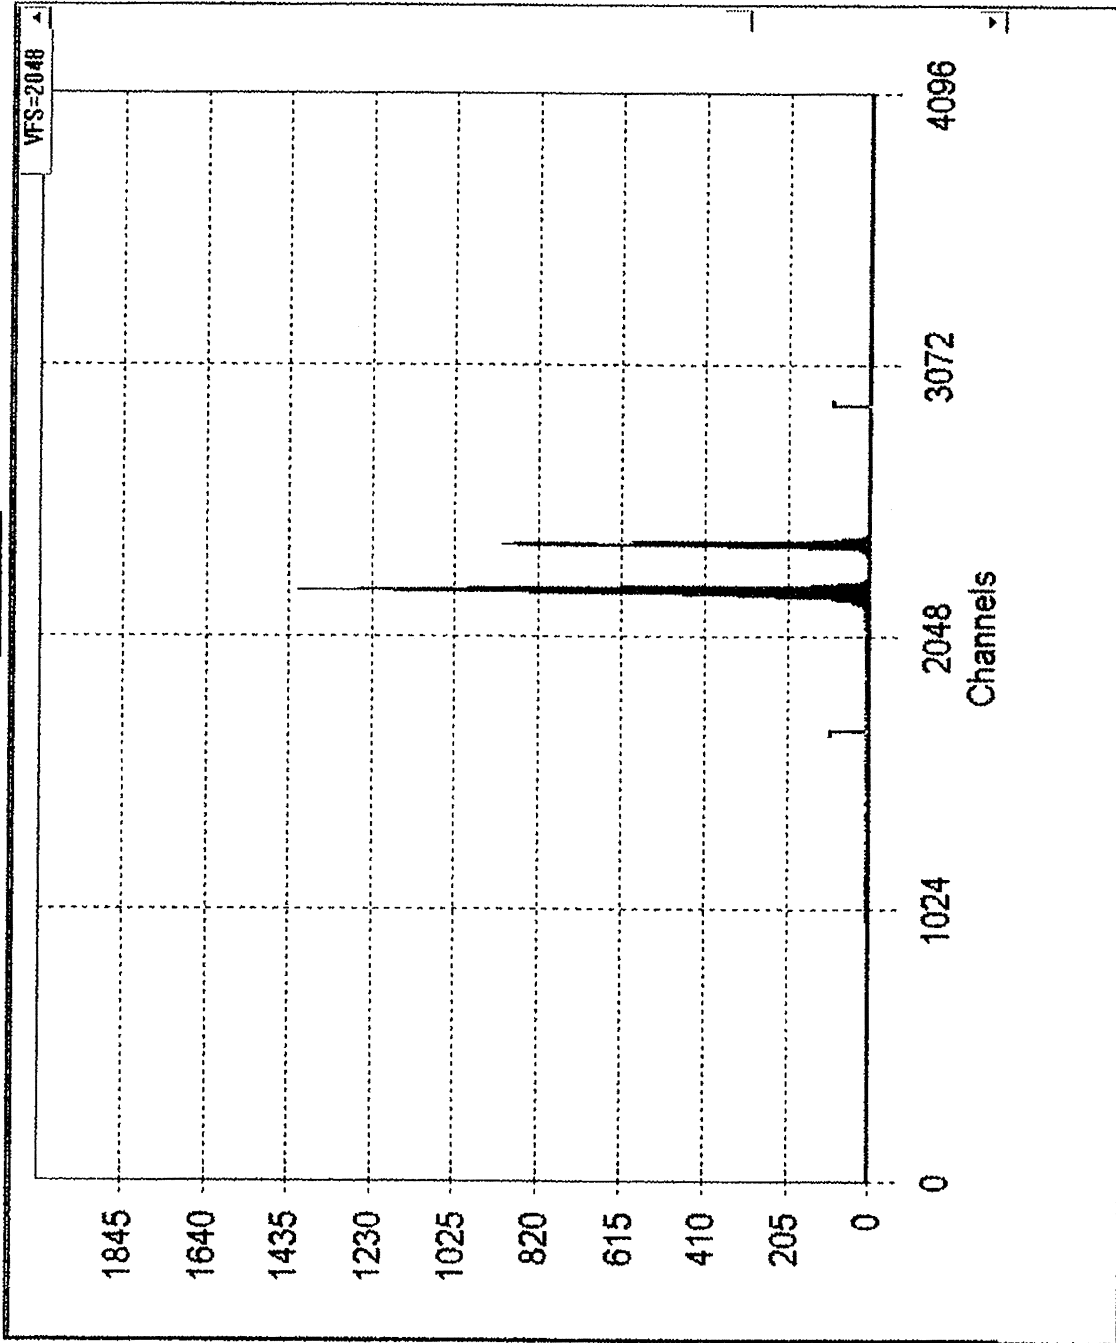
Resolution Mod

BIAS VOLTS= 310 V Leakage 2134 nA

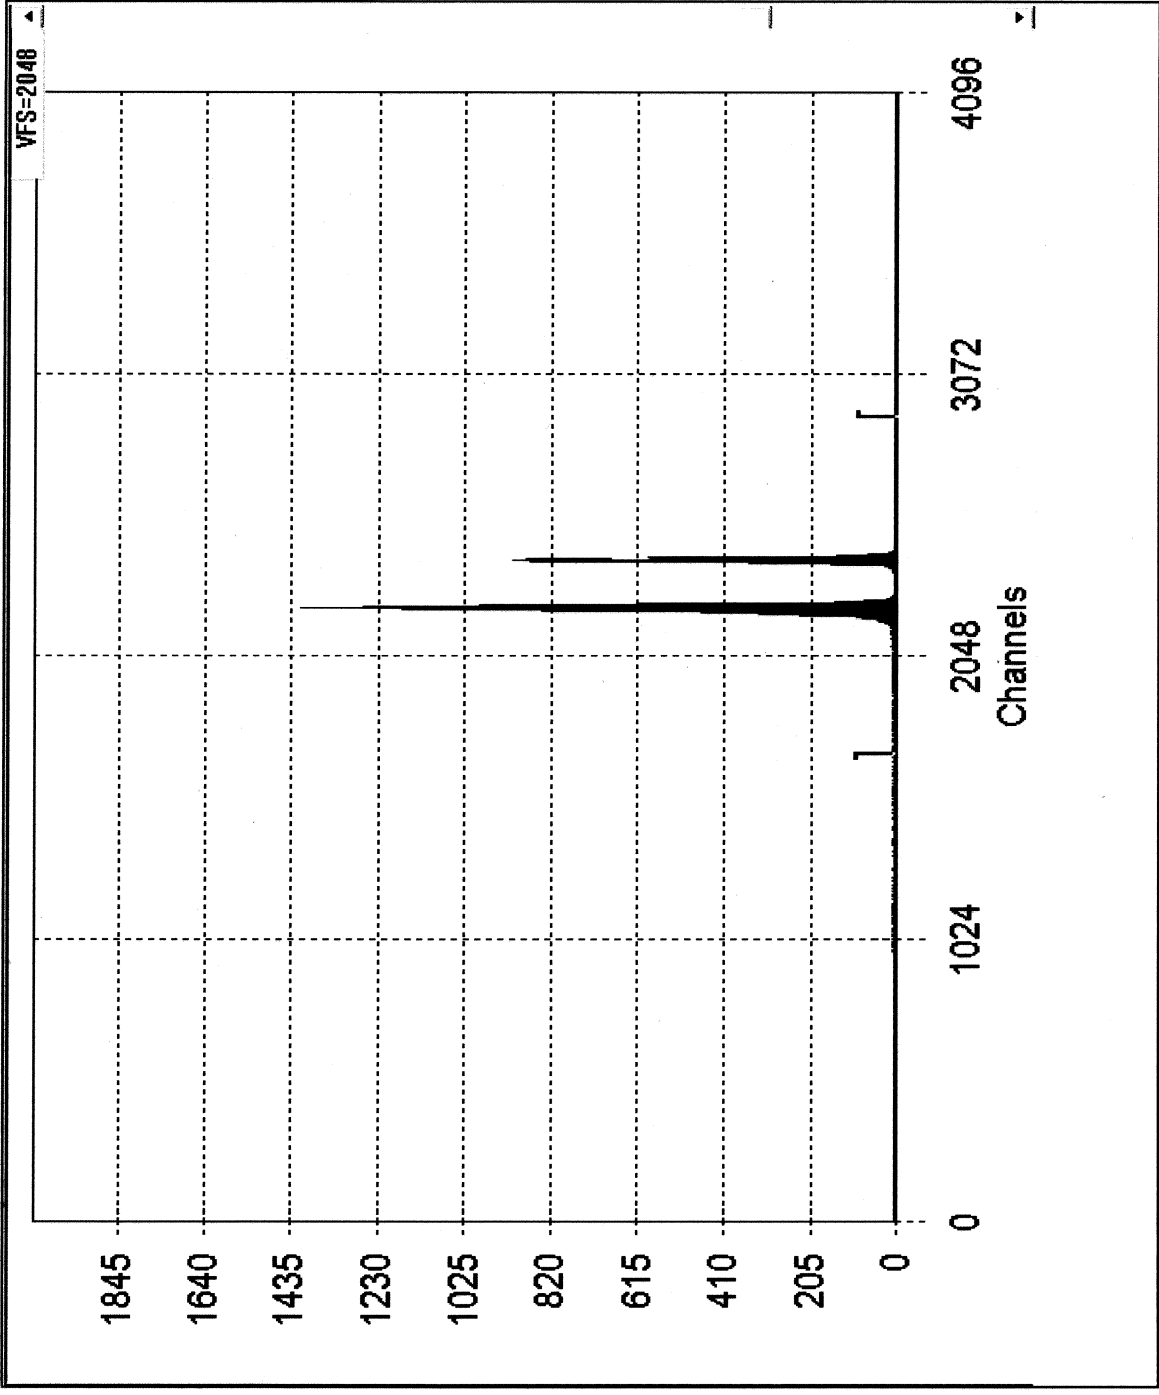
Resolution Plot

BIAS VOLTS= **350** V Leakage **2900** nA
