**CRYOGENIC LEAK TEST PROCEDURE FOR A LARGE
SUPERCONDUCTING CYCLOTRON COIL**

M.L. MALLORY, H.P. HILBERT and H.W. LAUMER

OCTOBER 1984

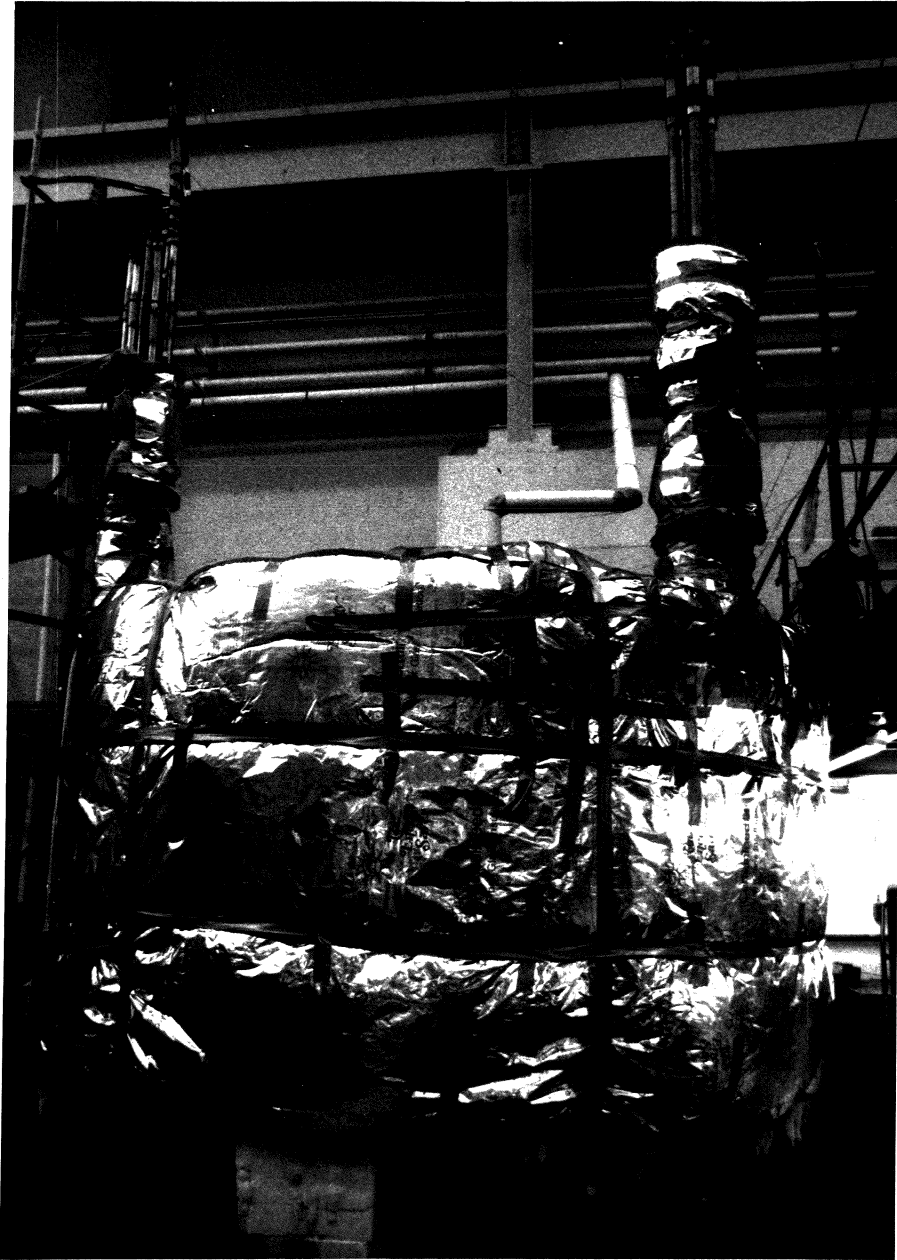
The coil temperature sensors were used to monitor the liquid nitrogen cryoshocking. The temperature difference between various coil sections (numbers) were less than 100 K. The steps in cooling rate coincide with changing the water tap points in the LN₂ heat exchanger. Liquid nitrogen completely filled the coil after four days of cooling.

This created the problem of large thermal stress during cooldown which potentially could cause overstressing of the coil and its banding. This problem was avoided by building a heat exchanger with multiple tap points. The liquid nitrogen enters the heat exchanger and is warmed by a counter flow of hot water before entering the K800 bobbin. The K800 coil temperature instrumentation was used to monitor the coil cooldown temperature. By adjusting the liquid nitrogen flow and the water tap points, the temperature difference between sections in the coil was kept at less than 100 K, (figure 3) thereby keeping the differential thermal stress in the design range of later normal coil cooling cycles.
