WIREBONDS STATUS

TJR 17

Wafer No.: 2085-11

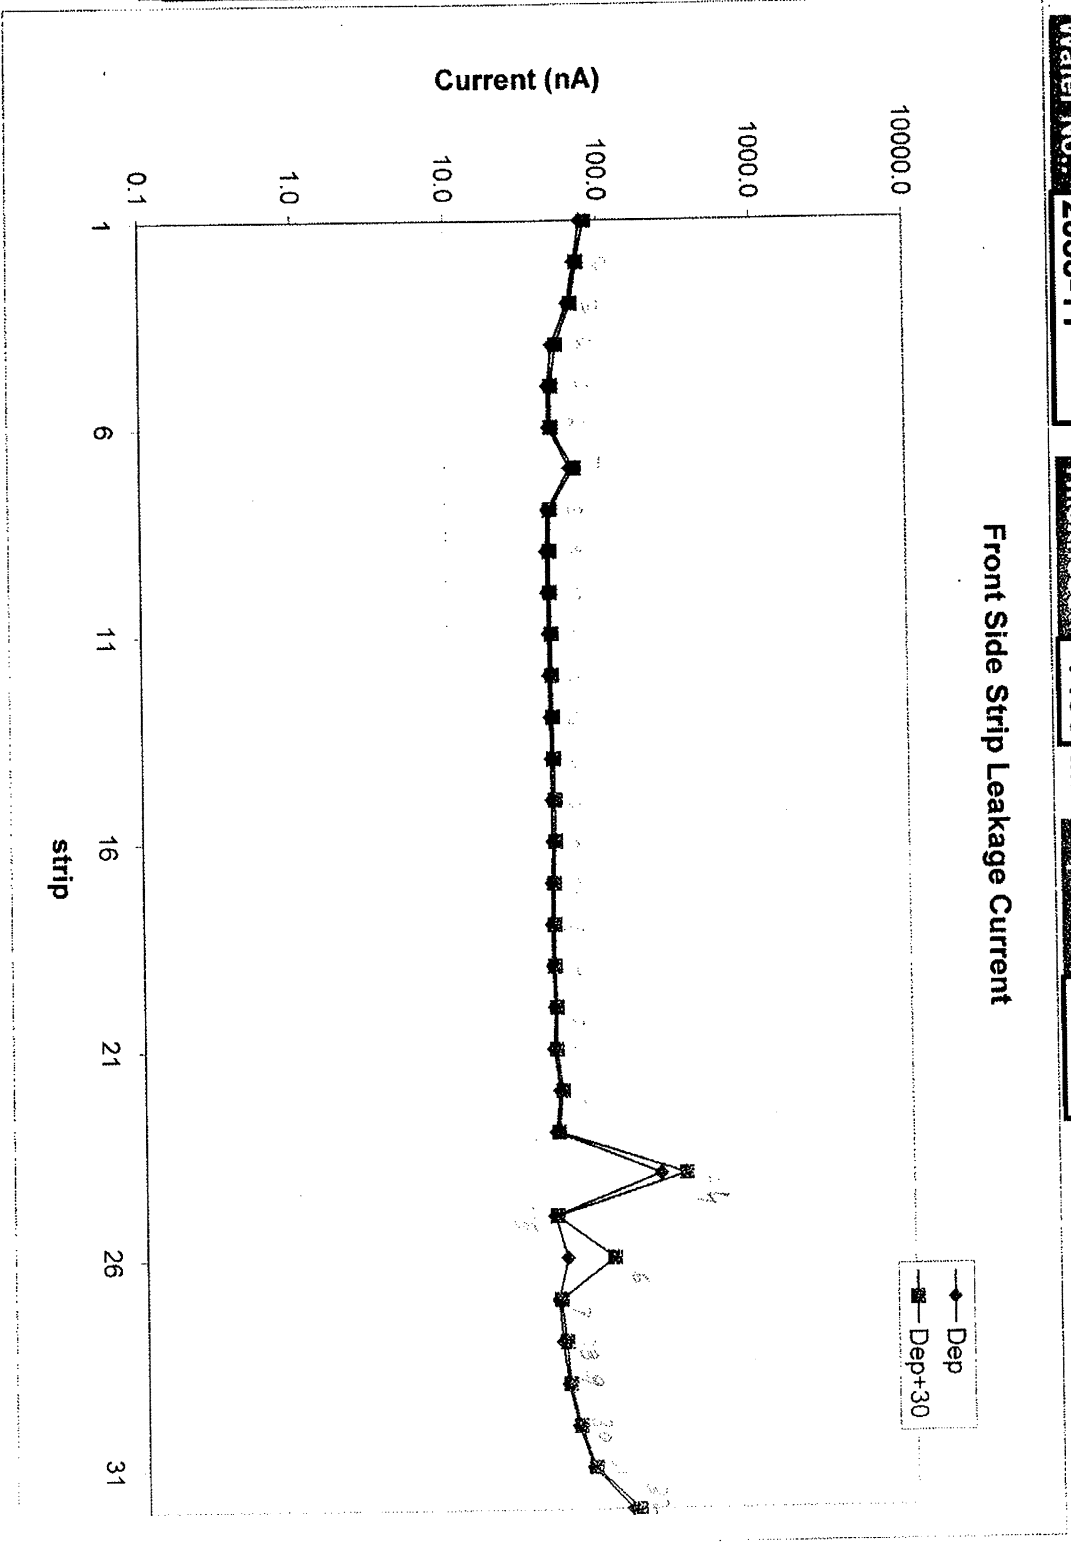
Front Side Data

Thickness: 1496 μm Vop

300 Volts

Strip	Current (nA)	Dep+30
1	77.59	82.38
2	70.34	72.85
3	63.53	66.44
4	50.07	53.13
5	46.94	48.97
6	47.07	48.89
7	64.37	68.33
8	45.75	47.37
9	44.87	46.72
10	44.93	46.76
11	45.62	47.31
12	45.46	47.25
13	45.81	47.59
14	46.16	47.88
15	46.49	48.61
16	46.63	48.62
17	45.72	47.32
18	45.7	47.3
19	45.71	47.29
20	46.88	48.31
21	45.77	47.68
22	49.7	51.82
23	46.63	48.5
24	223.8	327.8
25	44.98	46.48
26	54.35	108.45
27	46.93	48.69
28	49.61	52.6
29	53.64	54.97
30	62.49	64.19
31	77.03	79.23
32	138.06	152.68
Total	1908.6	2142.21

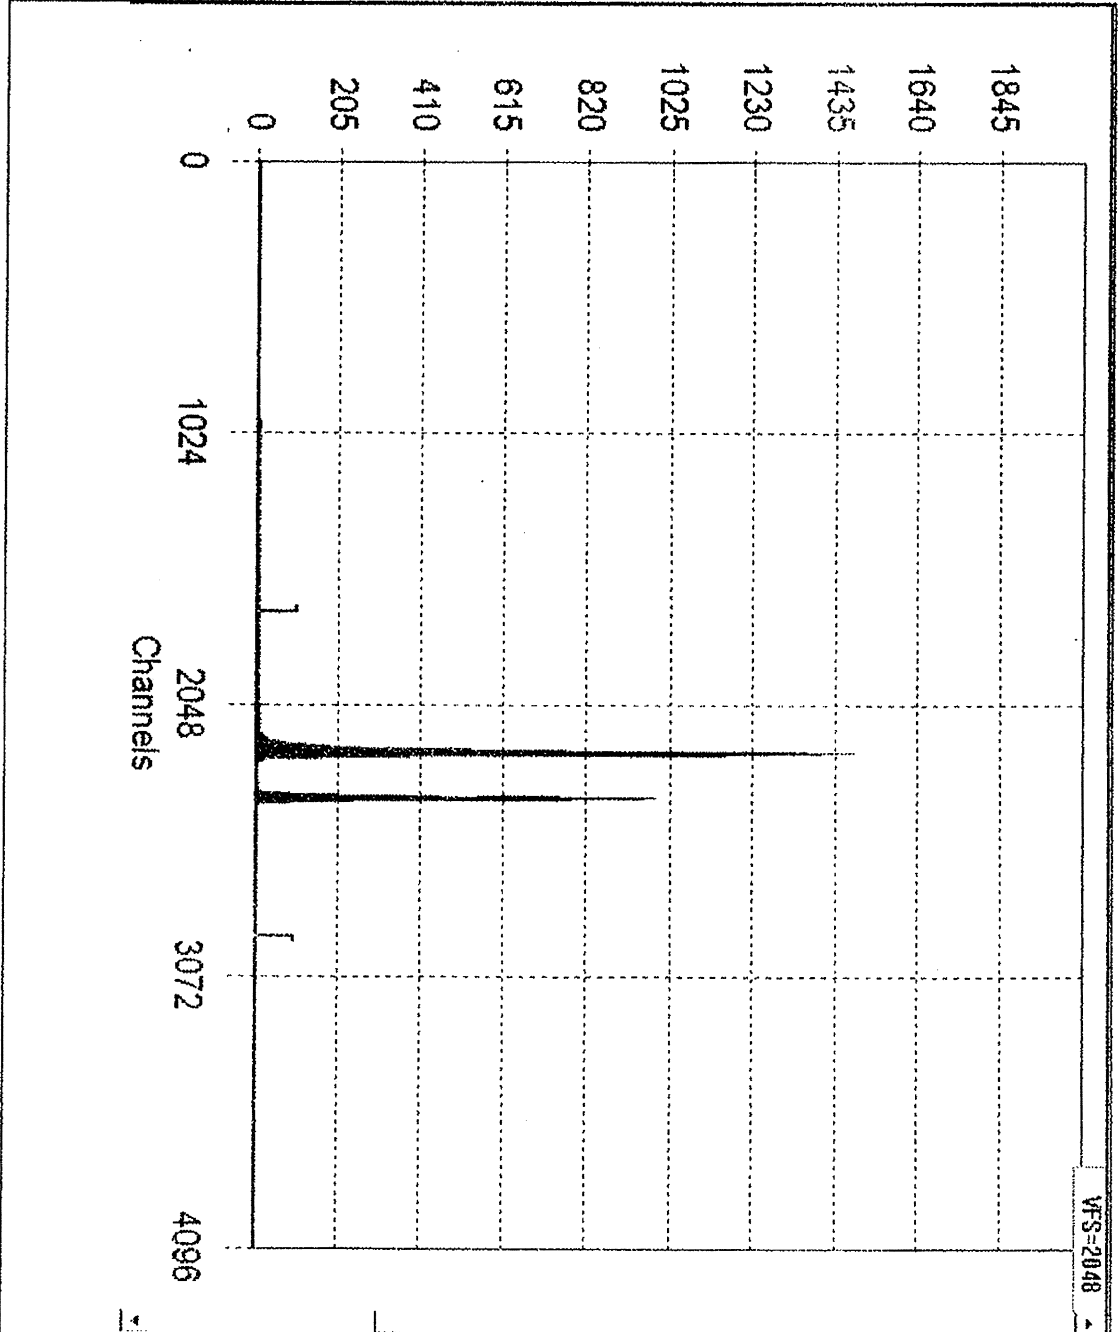
Resolution Test

HIRA BB7-1500

Wafer No.: 2085-11

Thickness: 1496 μm

JUNCTION

DET LINE: 56.3 Kev
SYSTEM: 43.5 Kev
CAL: 35.7 Kev

SEMIC

DET LINE: 57 Kev
SYSTEM: 43 Kev
CALC: 37.4 Kev
