WIREBONDS STATUS

TJR 2

ΔE = 2266-4
E = 2085-6

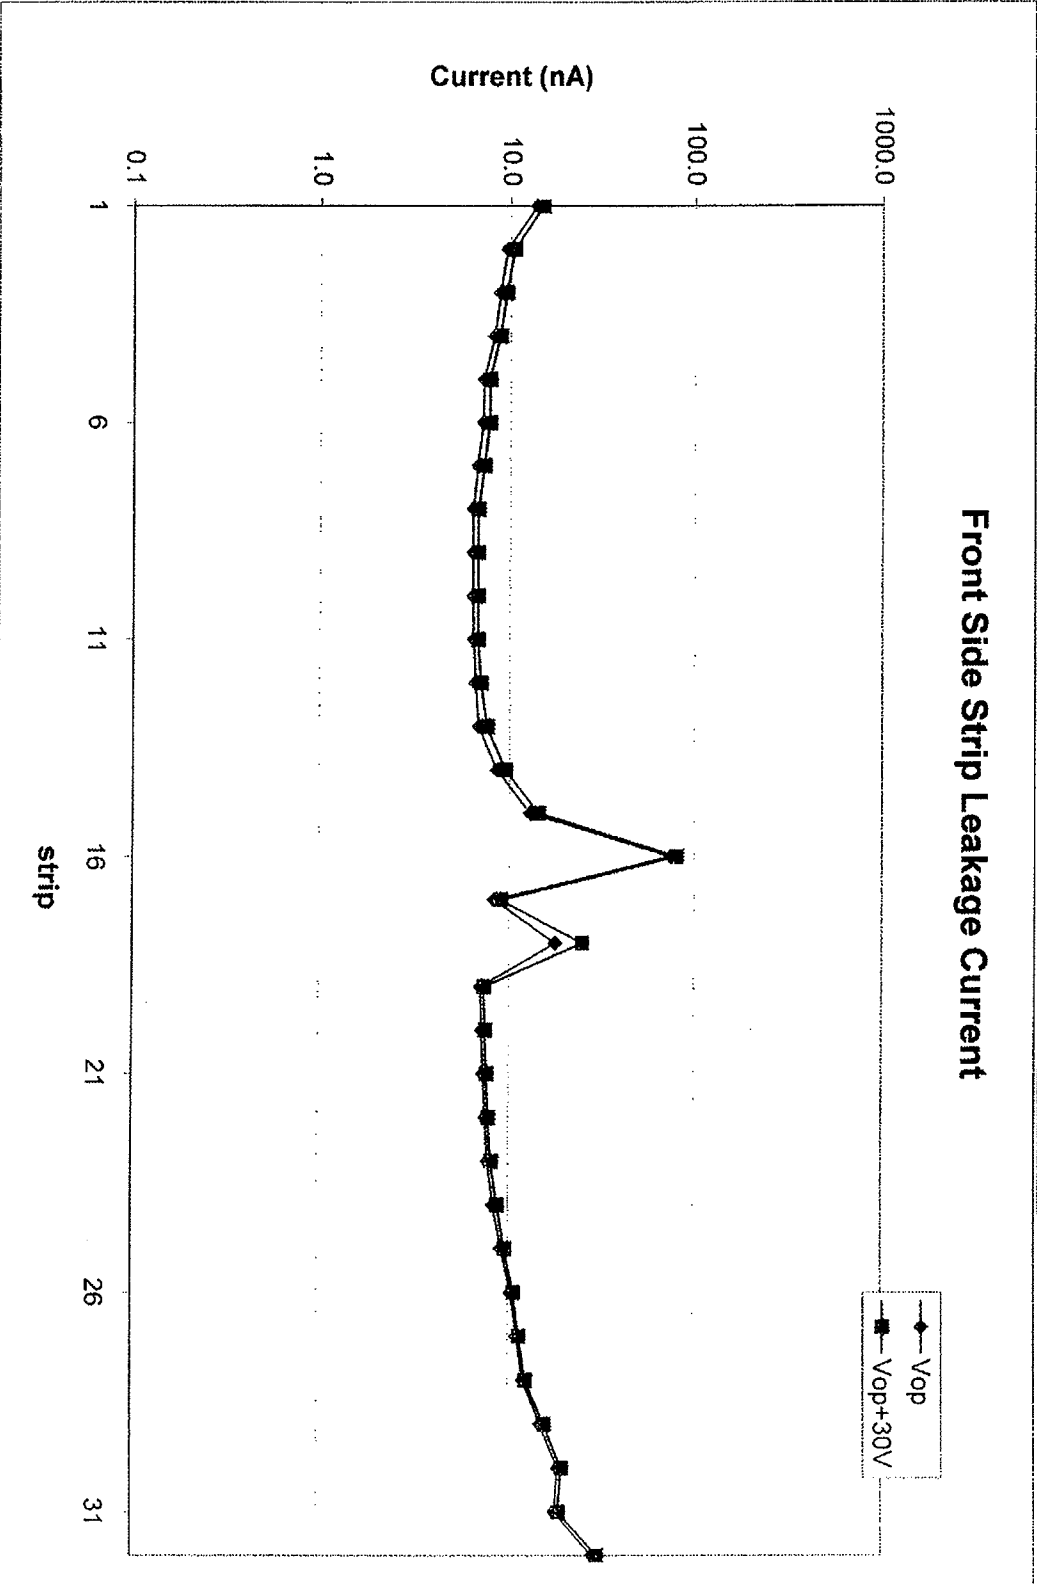
Front Side Data

Processor **BB7-1500**

Wafer No. **2085-6**

Thickness: **1490** μm

VOLTAGE Op. **280** Volts

Strip	Vop	Vop+30V
1	13.842	14.911
2	9.595	10.483
3	8.786	9.493
4	8.217	8.804
5	7.227	7.772
6	7.16	7.755
7	6.723	7.29
8	6.352	6.795
9	6.337	6.755
10	6.345	6.753
11	6.425	6.8
12	6.559	7.027
13	6.835	7.591
14	8.576	9.486
15	12.815	14.262
16	74.73	80.17
17	8.284	8.941
18	17.532	24.45
19	7.078	7.369
20	7.174	7.503
21	7.357	7.655
22	7.527	7.816
23	7.806	8.132
24	8.351	8.75
25	9.204	9.58
26	10.291	10.665
27	11.07	11.413
28	11.97	12.377
29	14.848	15.581
30	18.43	19.3
31	17.625	18.5
32	27.97	29.85
Total	389.04	420.039

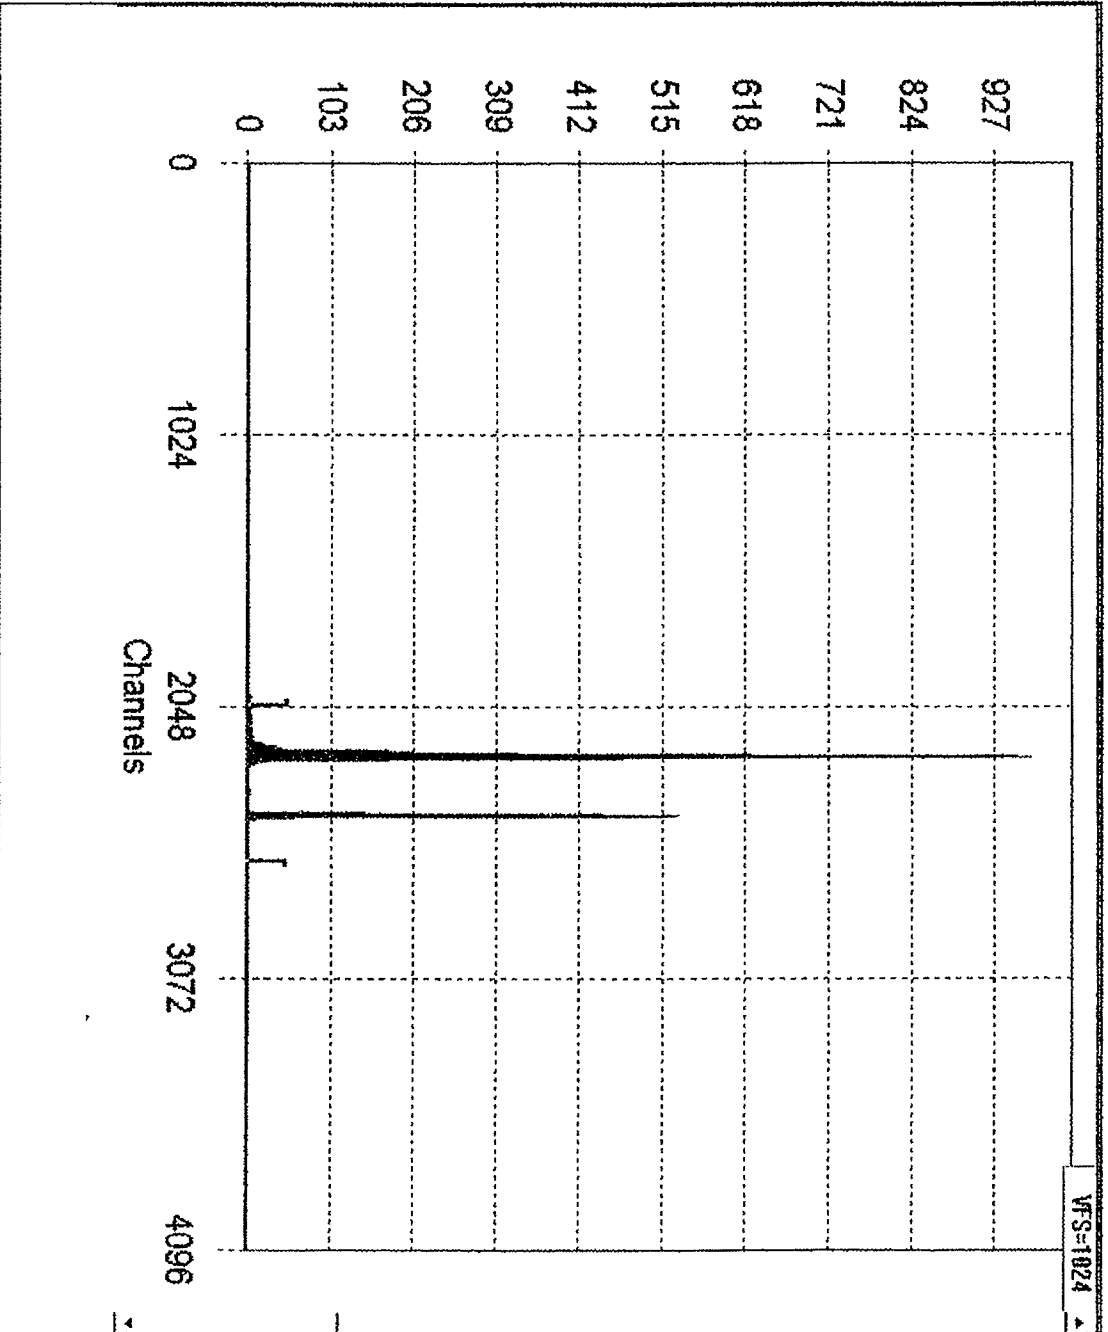
Resolution Plot

HIRA BB7-1500

Wafer No.: 2085-6

Thickness: 1490 μm

JUNCTION

DET LINE: 41.7 KeV
SYSTEM: 21 KeV
CAL: 36 KeV

OHMIC

DET LINE: 43 KeV
SYSTEM: 20.8 KeV
CALC: 37.5 KeV

BIAS VOLTS= 300 V Leakage 500 nA

Source Am 241
